**MARINE CORPS AIR STATION EL TORO  
EL TORO, CALIFORNIA  
INSTALLATION RESTORATION PROGRAM  
FINAL RCRA FACILITY ASSESSMENT REPORT**

**VOLUME IV**

**16 July 1993**

**MARINE CORPS AIR STATION  
EL TORO  
EL TORO, CALIFORNIA  
INSTALLATION RESTORATION PROGRAM  
RCRA FACILITY ASSESSMENT  
DRAFT PRELIMINARY REVIEW/  
VISUAL SITE INSPECTION REPORT  
VOLUME II**

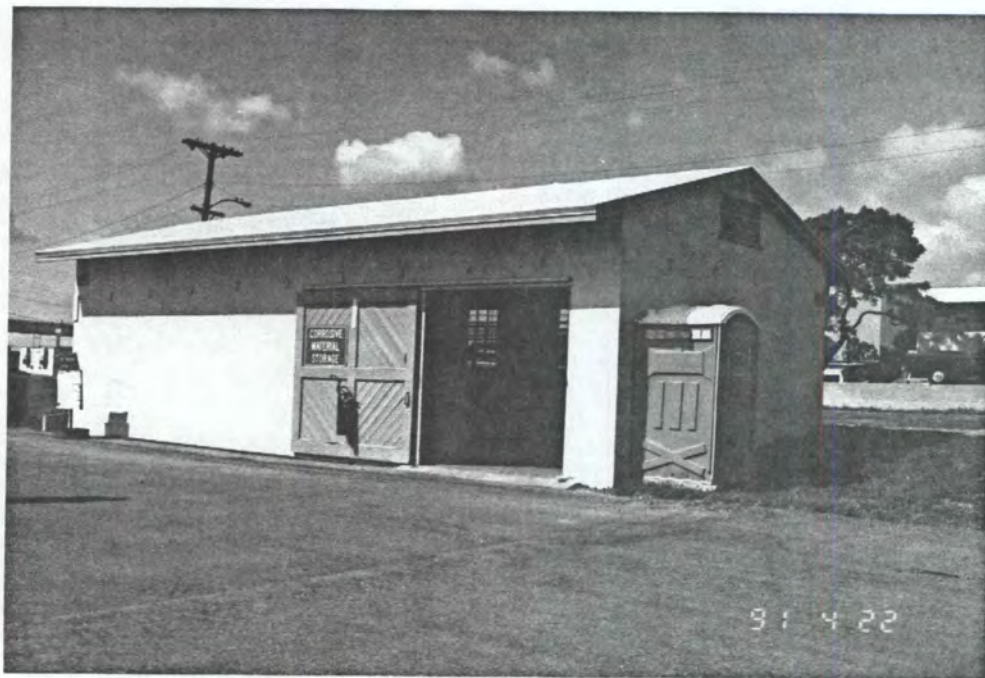
Building 534 is a drum storage facility for corrosive materials. The building is a one-room structure, approximately 800 sq ft. Corrosive materials such as sulfuric acid, phosphoric acid, and batteries are stored inside the building on a concrete floor. A drain, leading to an unknown destination, is located in the center of the building. There are no significant stains or cracks in the concrete flooring.

No evidence of a release was observed at this area. No further action is recommended for this SWMU/AOC.

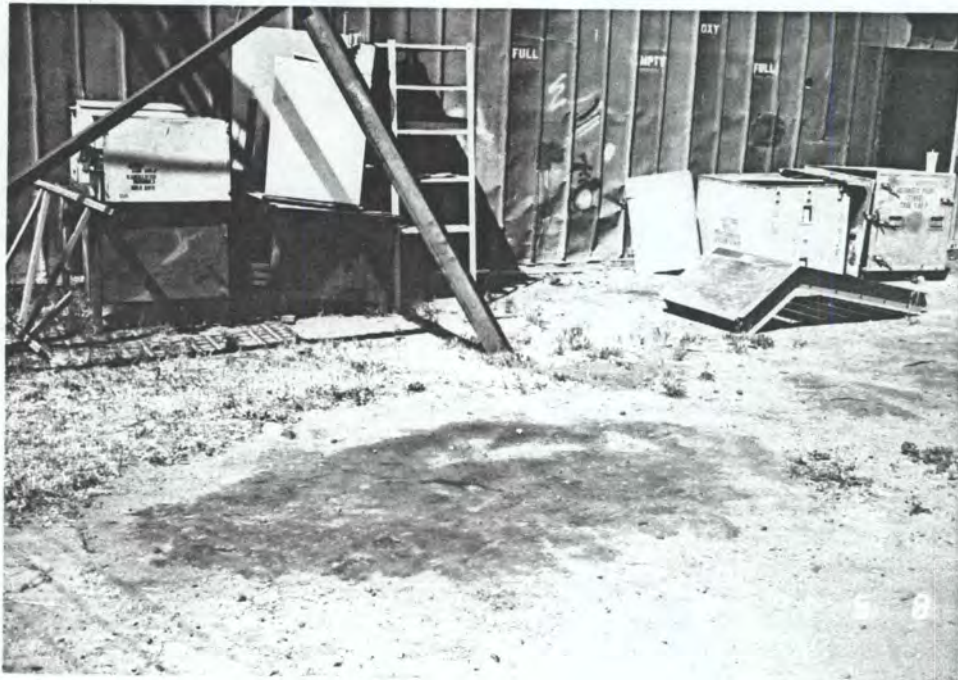
Stained soil located on the northeast side of Building 602 adjacent to the probable site of the former DSA

A sampling visit is recommended for this area.

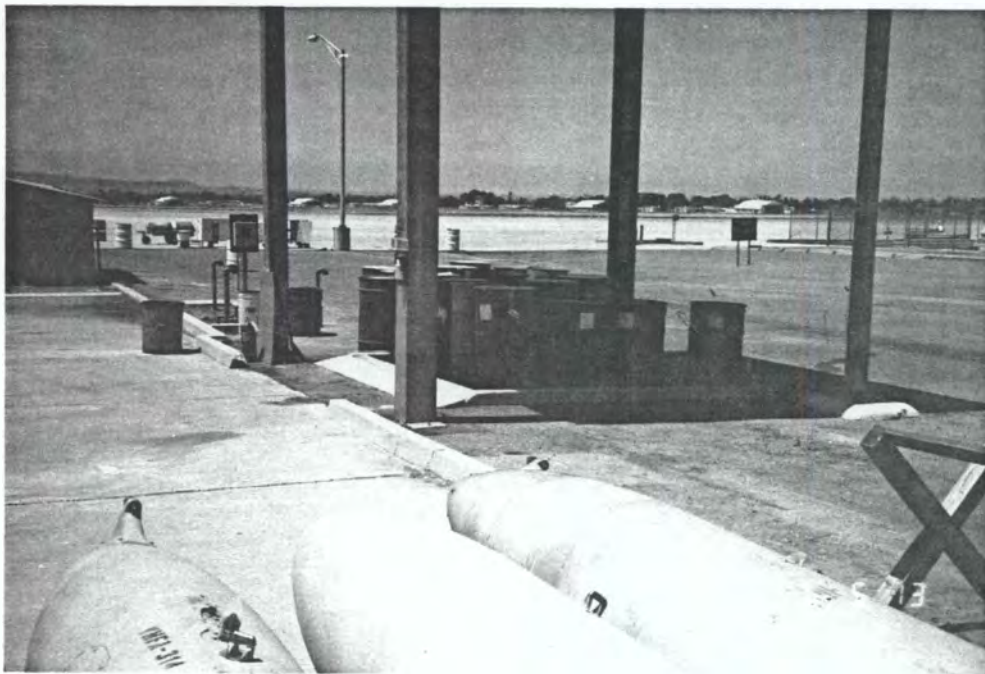
A hazardous waste storage area (HWSA) is located northwest of Building 605 adjacent to the aircraft wash area (SWMU/AOC Number 150); an oil water separator (SWMU/AOC Number 151) is located approximately 11 feet to the west. The HWSA consists of a 12-ft x 12-ft concrete pad with concrete berms and an aluminum covering. A concrete access ramp is located on the south side of the HWSA. The HWSA is bordered on all sides by asphalt pavement. The edge of the concrete washpad is located approximately 2 ft south of the HWSA. Some dark stains were observed on the concrete storage pad, on the asphalt and concrete surfaces south of the HWSA, and also on the asphalt pavement north of the HWSA.

Dark stains located on concrete storage pad and asphalt and concrete pavement bordering the HWSA

Although there is no evidence of a release to soil at the stained areas, this site, as a HWSA, is recommended for a sampling visit.

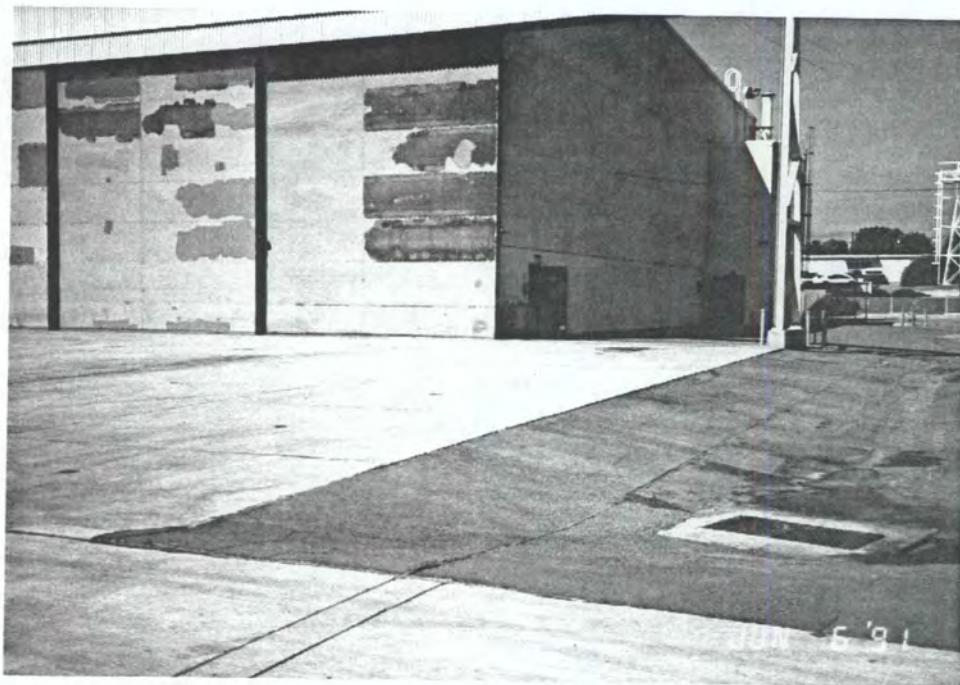
The aircraft wash area for Building 606 is located in front of the southwestern corner of the building on the concrete parking apron. The wash area measures approximately 1,000 sq ft in size. The wash area is unbermed. It is sloped so that runoff flows in a westerly direction toward the tarmac or toward a storm drain located approximately 15 ft east of the southwestern corner of the washrack in an asphalt-paved area. The drain appears to be connected to Oil/water Separator 606-C (SWMU/AOC Number 154). The washrack is characterized with light, widespread staining on the concrete wash area, and dark staining on the asphalt surrounding the storm drain. No significant cracks were observed.

Lightly stained wash area and area near drain

The washrack is constructed of concrete that is sloped to collect the wash water in drains connected to an oil/water separator. The concrete appeared to be free of cracks or defects. No further action is recommended for this SWMU/AOC.

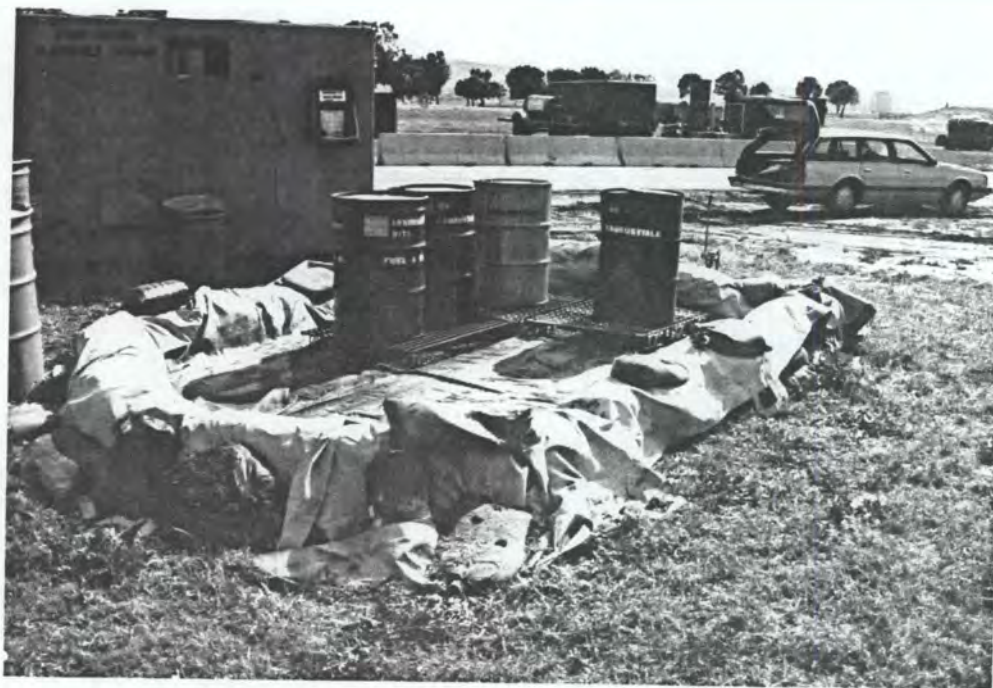
A HWSA is located approximately 65 ft southeast of Building 636. The HWSA consists of a sandbag berm encompassing an 11-ft x 16-ft area. The berm is 1 to 2 ft in height. A canvas sheet is draped over the berm and provides the lining for the HWSA. The HWSA is located on an unpaved, unprotected soil area. The canvas is darkly stained within the bermed area. A tear in the canvas liner was observed near the southeastern corner within the HWSA. Drums within the HWSA are stored on metal pallets. The HWSA is bordered on all sides by grassy or bare soil areas. No stains on the unpaved areas in proximity to the HWSA were visually observed.

Stains on the canvas liner of the HWSA

Since this HWSA is located on unpaved soil covered by a liner, which is stained and has a torn section, it is likely that soil may have been impacted by spills. This HWSA is recommended for a sampling visit.

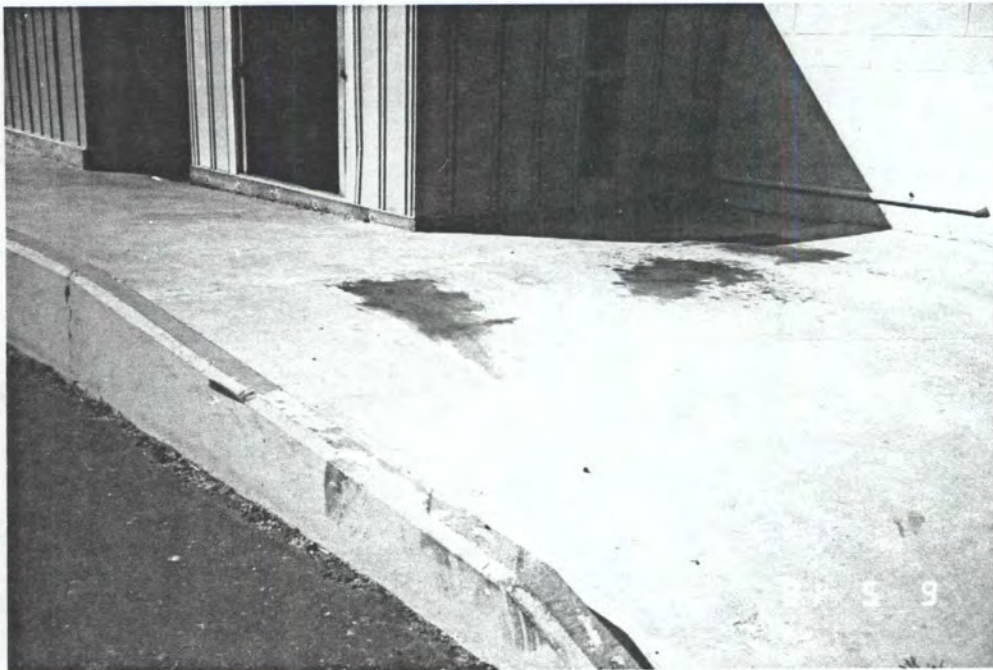
A vehicle washrack is located adjacent to the western wall of Building 652. The washrack consists of a 15-ft x 31-ft concrete wash pad, which is elevated approximately 2 ft. Concrete ramps extend approximately 9 ft north and south of the pad. The pad has a concrete berm along the western side, which also borders the concrete ramps. A drain leading to an oil/water separator (SWMU/AOC Number 169) is located in the center of the washpad. A liquid approximately 1 ft below grade was observed in the drain. The liquid appeared green in color, resembling antifreeze. The pad is bordered by asphalt pavement on the western side and on the northern and southern sides beyond the concrete ramps, and abuts the western wall of Building 651 to the east. The washrack is no longer active.

Although there is no evidence of a release, this washrack has been used for storage of hazardous waste. A sampling visit is recommended for this reason.

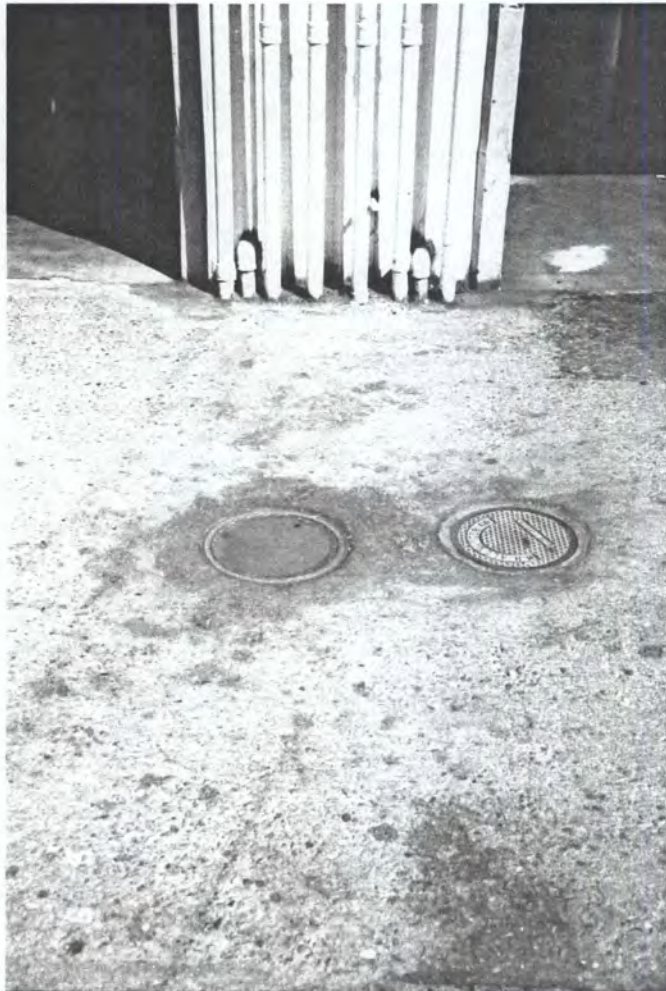
Stained asphalt around fill box

This UST passed a tank test conducted in 1990 under CTO #0006-01 in the Navy CLEAN Program. The stained asphalt around the fill box represents minor spillage during loading/unloading operations that has not impacted underlying soil. No further action is recommended for this SWMU/AOC.

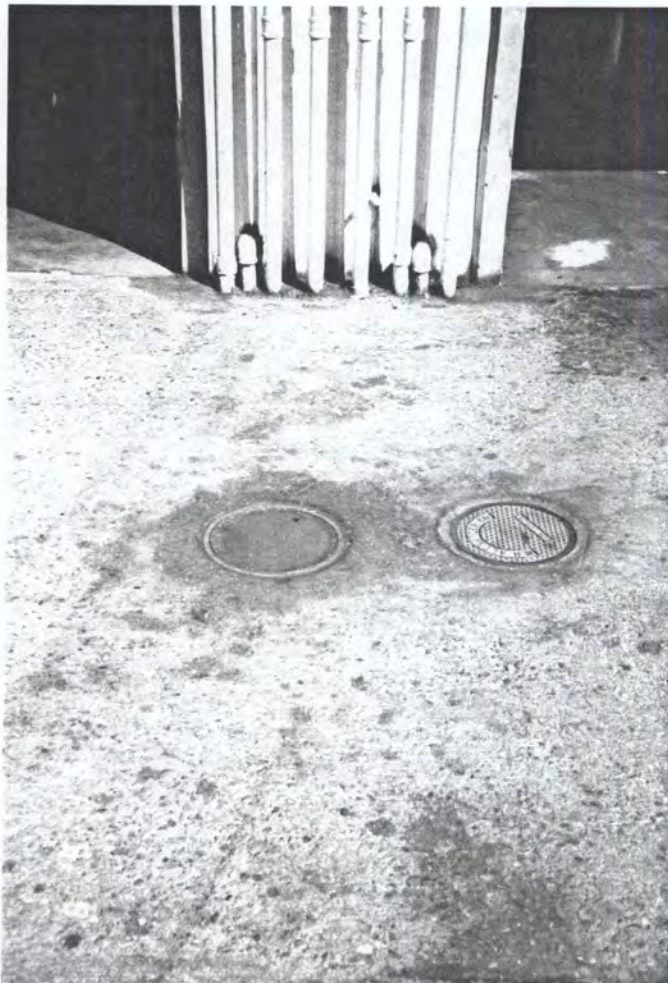
Stained asphalt around fill box

This UST passed a tank test conducted in 1990 under CTO #0006-01 in the Navy CLEAN Program. The stained asphalt around the fill box represents minor spillage during loading/unloading operations that has not impacted underlying soil. No further action is recommended for this SWMU/AOC.

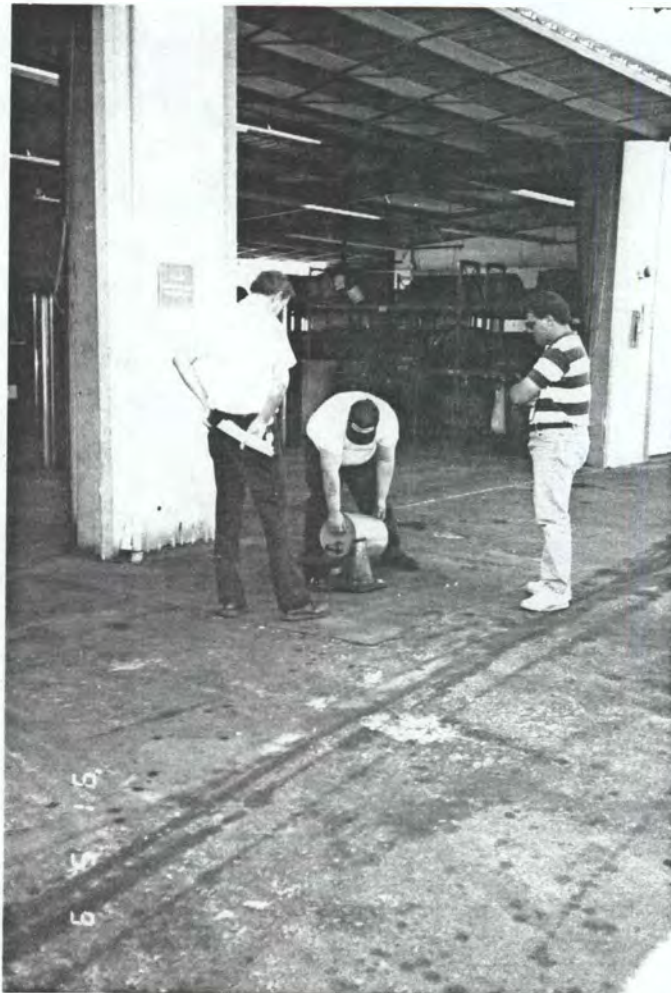
UST 651-7 is located on the southern side of Building 651, situated opposite the location of Tanks 651-5 and 651-6 (SWMU/AOC Numbers 166 and 167, respectively). The 500-gallon steel tank was installed in 1971 and is currently used to store waste oil. The fill box location is identified by a 3-in.-diameter pipe protruding approximately 4 in. from grade. The fill pipe is located in the center of a 6-ft x 6-ft concrete pad. The pad is darkly stained over its entire area. The pad is bordered to the east, west, and south by asphalt pavement; the northern side of the pad abuts a pillar between the third and fourth work bays of the service station at the southern wall of Building 651. The asphalt pavement bordering the pad has dark stains, but has no cracks.

Stains on pavement around fill box

This UST passed a tank test conducted in 1990 under CTO #0006-01 in the Navy CLEAN Program. The stained pavement reflects minor spillage during loading/unloading operations that has not impacted underlying soil. No further action is recommended for this SWMU/AOC.

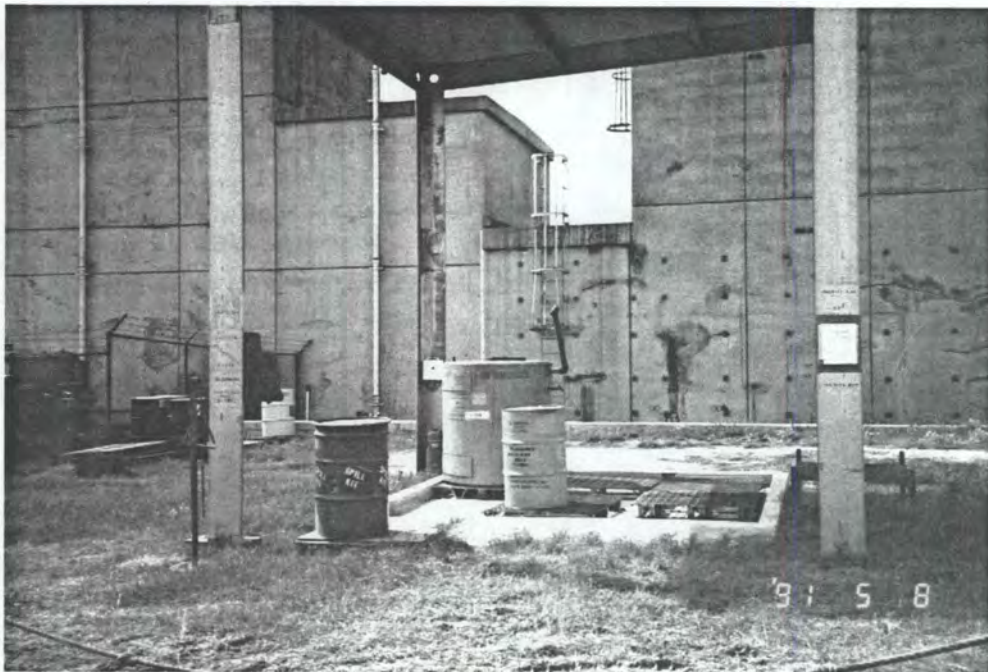
An HWSA is located approximately 35 ft south of Building 658. The HWSA consists of a concrete storage pad and a concrete berm with an aluminum roof. A sump is located in the southwestern corner of the concrete pad. The concrete pad has dark discoloration around the sump drain. No significant cracks in the concrete pad or berm were observed.

The HWSA is bordered by unpaved soil on all sides. An area of stained soil was observed near the northeastern corner of the HWSA. Also evidence of stressed vegetation was observed on the southern side of the HWSA.

Stained soil near HWSA

A release of waste to the soil surrounding this HWSA was observed during the site inspection. A sampling visit is recommended for this HWSA.

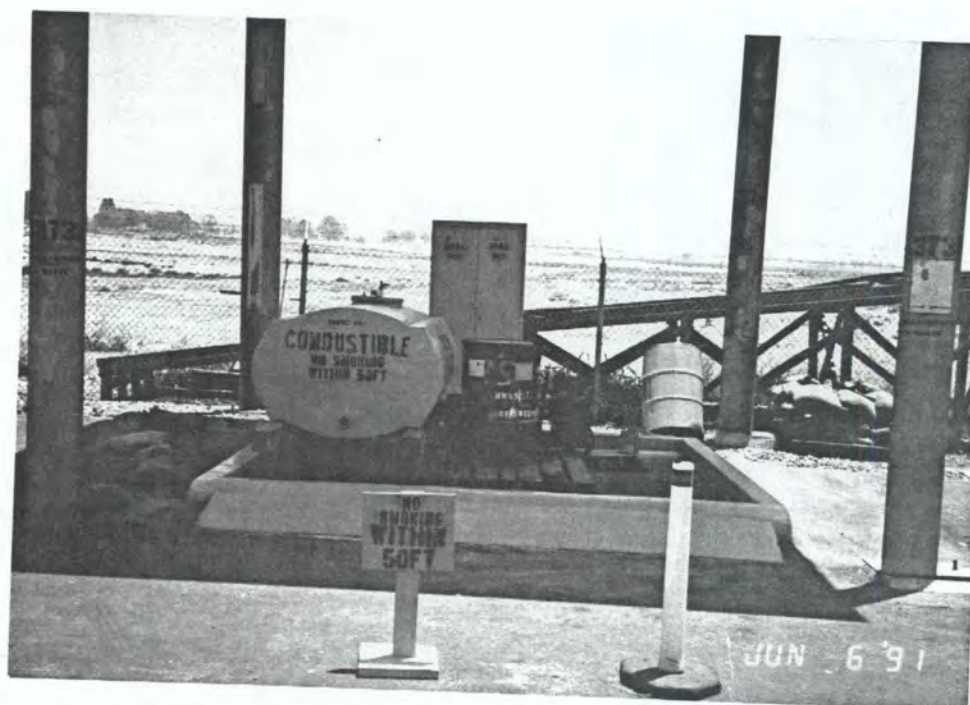
The storage pad had several dark stains; however, the stains did not appear to extend outside the storage area.

Stained storage pad

Although no evidence of a release outside of the HWSA was observed, the identified HWSAs at MCAS El Toro are typically being suggested for a sampling visit in this RFA. Therefore, a sampling visit is recommended for this HWSA.
